Ace Building Inspections

Property Address: Sydney Metro

Date Of Inspection: 1st January 2016

VISUAL BUILDING INSPECTION REPORT

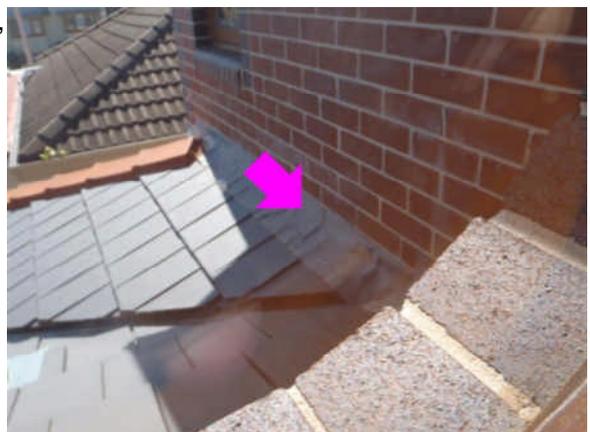
Flashing material is of lead. Flashing is cracked, missing, damaged or in poor condition and will require rectification. At the right hand side of the structure although other areas may also be effected. Some previous repairs have been carried out but extent of work is unknown.

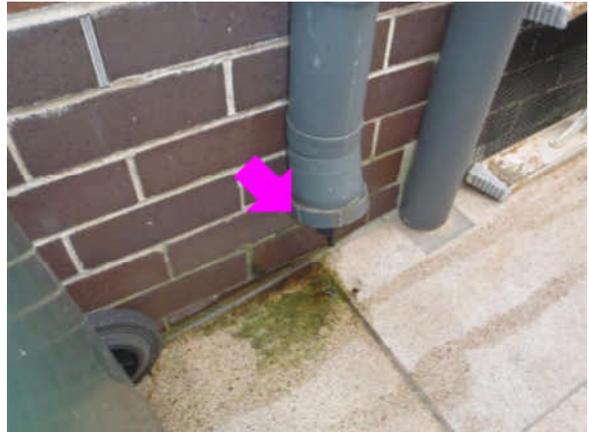
Guttering joints are leaking and should be repaired.

Appear to be in serviceable condition. Downpipes appear to be connected to the stormwater dispersal system, however, correct connection can only be confirmed with a smoke test. Guttering joints are leaking and should be repaired.

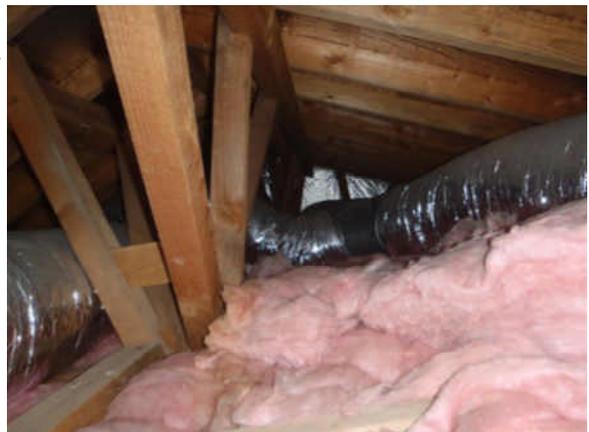
Sarking membrane and insulation is present in the roof cavity. This restricted inspection to some roofing timbers. Removal of insulation is not within the scope of a standard visual building inspection report. Ducting associated with air conditioning or heating restricted inspection. Where areas are restricted, removal of the restriction is required to enable a more complete report to be submitted.

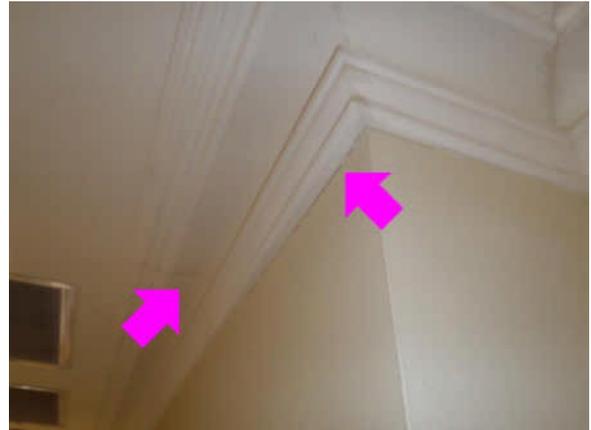
Various areas through out.

Minor cracking is present to cornices. This will require maintenance.

The condition of the ceilings is generally fair. Minor cracking is present to cornices. This will require maintenance.

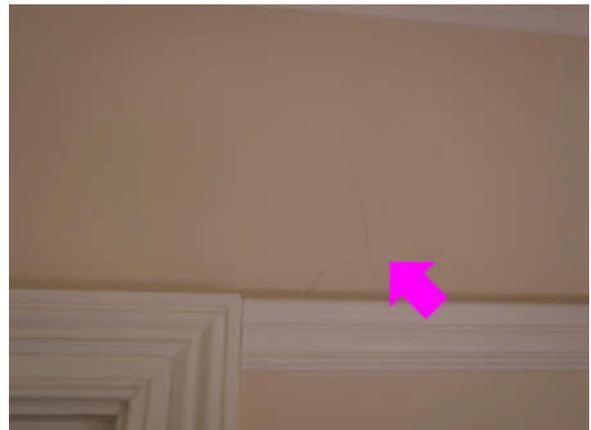
Hallway:

Cracks are evident. Visible cracking has been categorized as an appearance defect. Cracking of a building element is an appearance or surface defect where in the opinion of the inspector the appearance of the element is blemished however, the expected consequence of this cracking is unknown until further information is obtained.

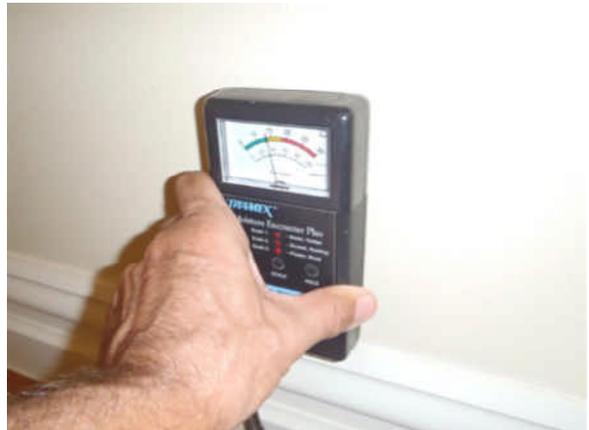
Rising Damp

Evidence of lateral damp was noted. This may be the result of a cavity bridge, plumbing leak or other undetected moisture source or defect. This situation should be further investigated and rectified.

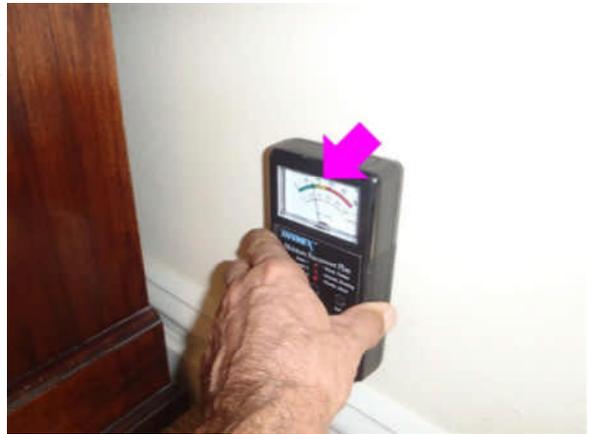
Evidence suggests the shower recess is leaking. Continued leakage may allow damage to surrounding components. Rectification will be required and the extent of works should be determined by a Licensed Builder.

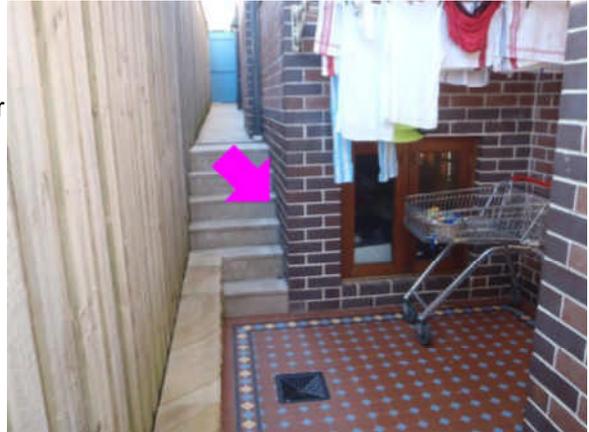
Right hand side elevation, Left hand side elevation.

The condition of the walls is generally good. The base of some walls are below the external soil levels and may be subject to lateral dampness or water entry. Recommend soil levels be lowered or the area be closely monitored for water entry/penetration.

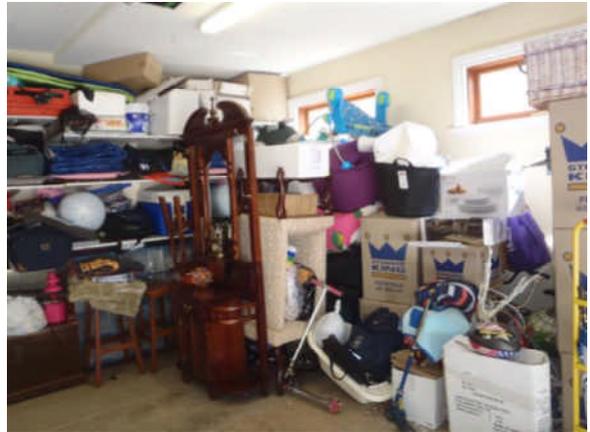
Stored items restricted inspection to the interior. Stored items should be removed to enable a more complete report to be submitted.

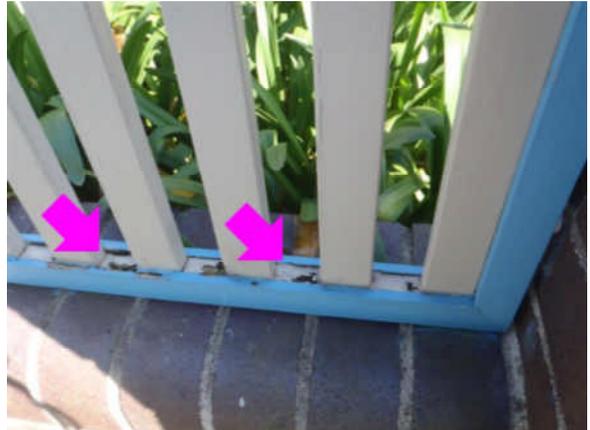
Right hand side: Left hand side: Front section:

Wet rot or defects were noted to the wooden fences and repairs or replacement is needed.

The fences are constructed from a combination of timber, brick and metal. The fences are generally in fair condition. Wet rot or defects were noted to the wooden fences and repairs or replacement is needed.

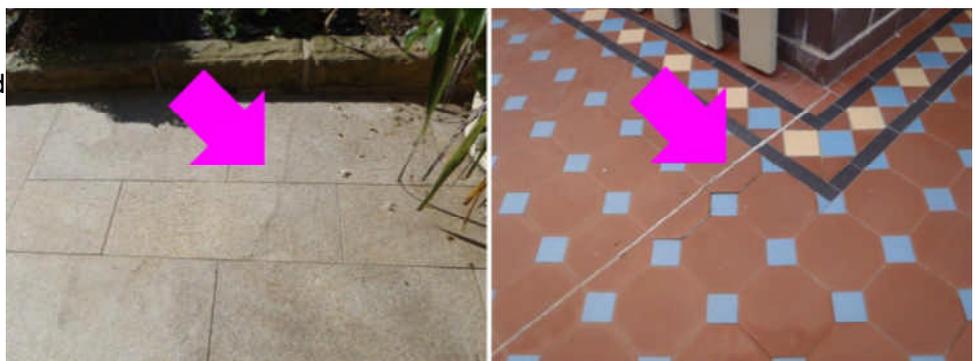
The concrete paths/paved areas are in fair condition. Loose/cracked tiles are noted.
